Conditions Assessment

SOUTH EGREMONT VILLAGE SCHOOL

June 2014

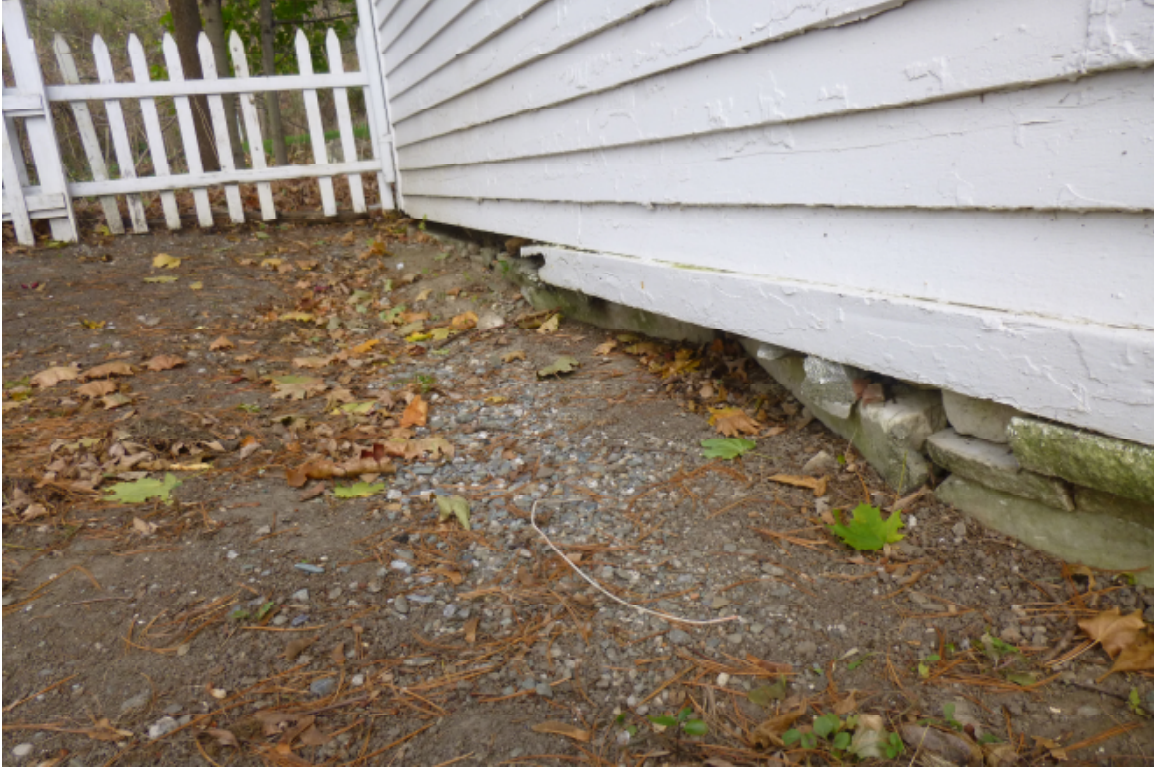
Approximately one-third of the top course of the west foundation wall has collapsed [Image 6]. The remaining stone foundation, with the exception of the south wall has little, if any, mortar left in the joints. The concrete east wall of the addition is severely eroded [Image 7]. The southeast corner of the sill is exposed where trim has deteriorated. [Image 8] There is significant deterioration in the rear one-quarter of the western wood sill and the sill is missing entirely at the northwest corner. The north foundation is not readily accessible without entering adjacent private property [Image 9].

Image 6: Approximately one-third of the west foundation wall is in need of repair. The remaining stone foundation, with the exception of the south wall has little, if any, mortar in the joints. (South Egremont Village School, January 2014)

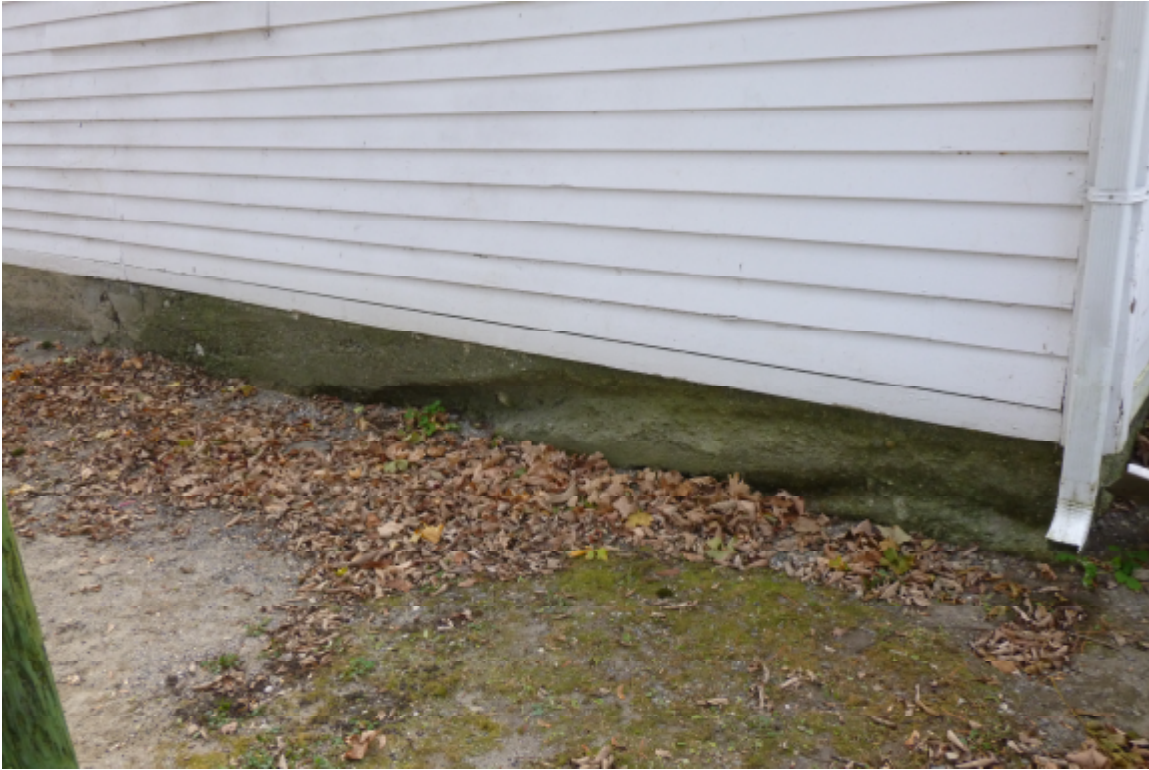
Image 7: The concrete east wall of the circa 1900 addition is severely eroded. (South Egremont Village School, January 2014)

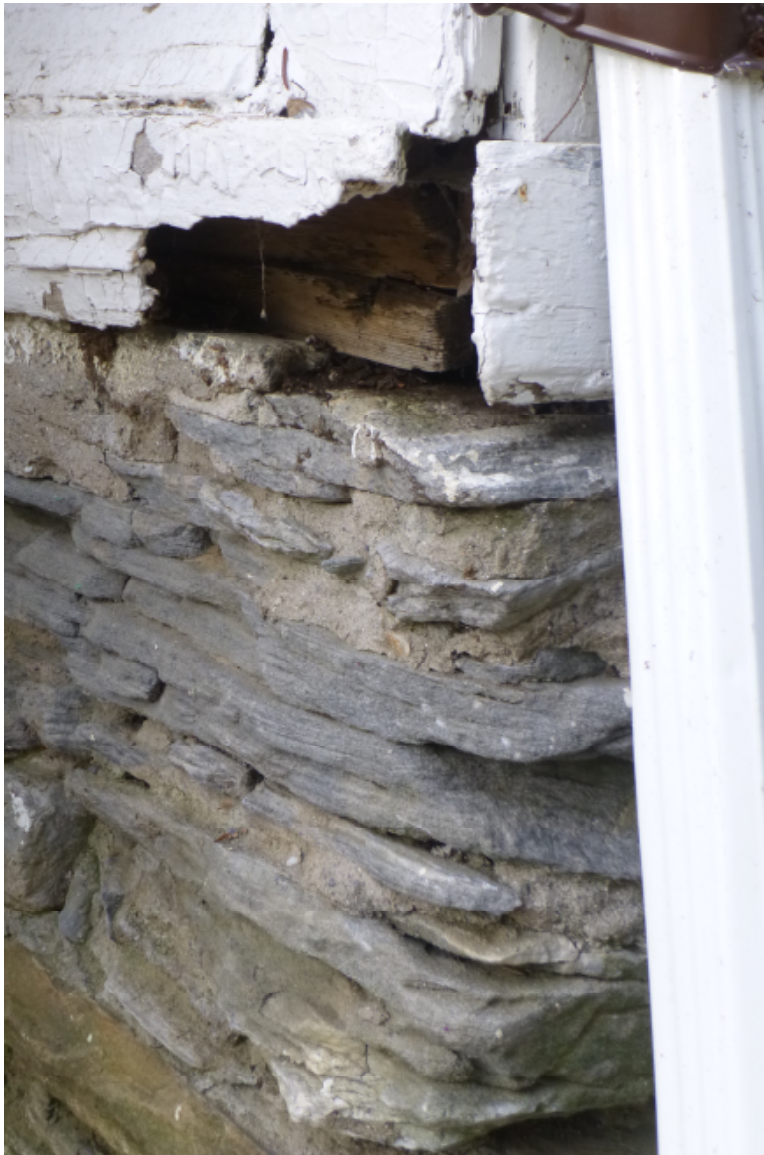
Image 8: The sill is exposed at the southeast corner of the building and trim will require repair. (South Egremont Village School, January 2014)

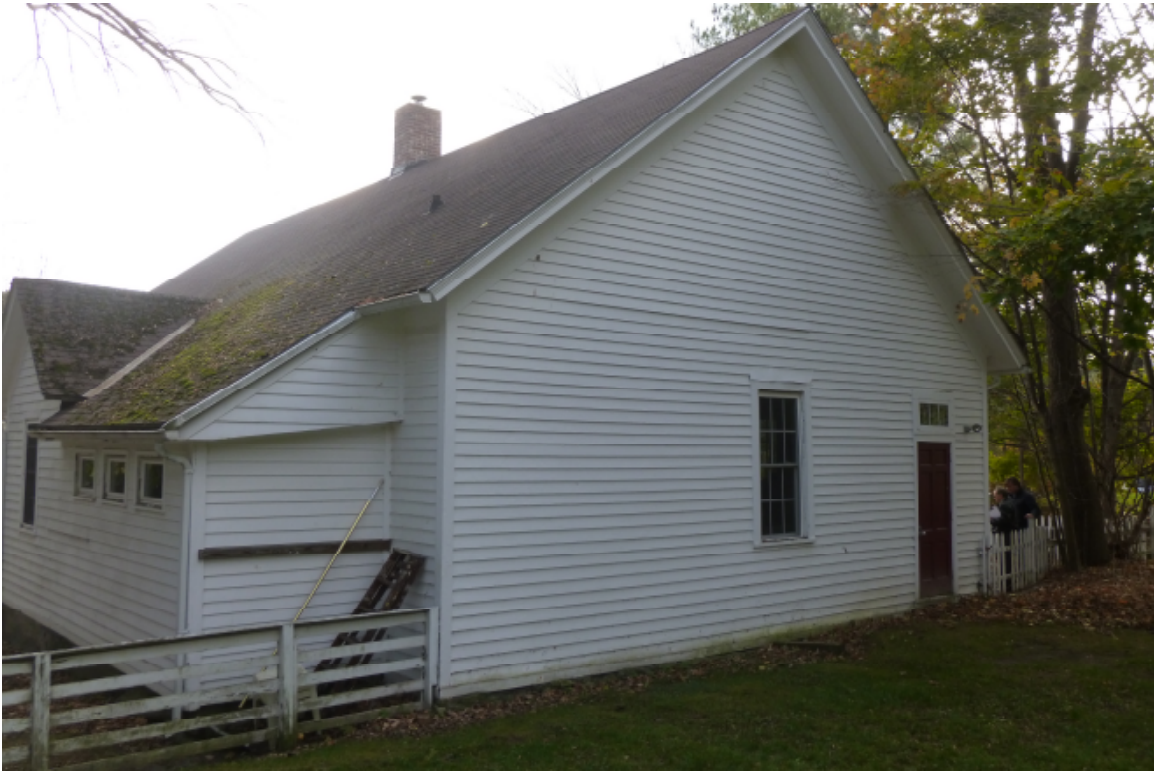
Image 9: The north elevation forms the property lint at the rear of the building. Soil has built up against the building compromising the lower wood trim and possibly the sill. (South Egremont Village School, January 2014)

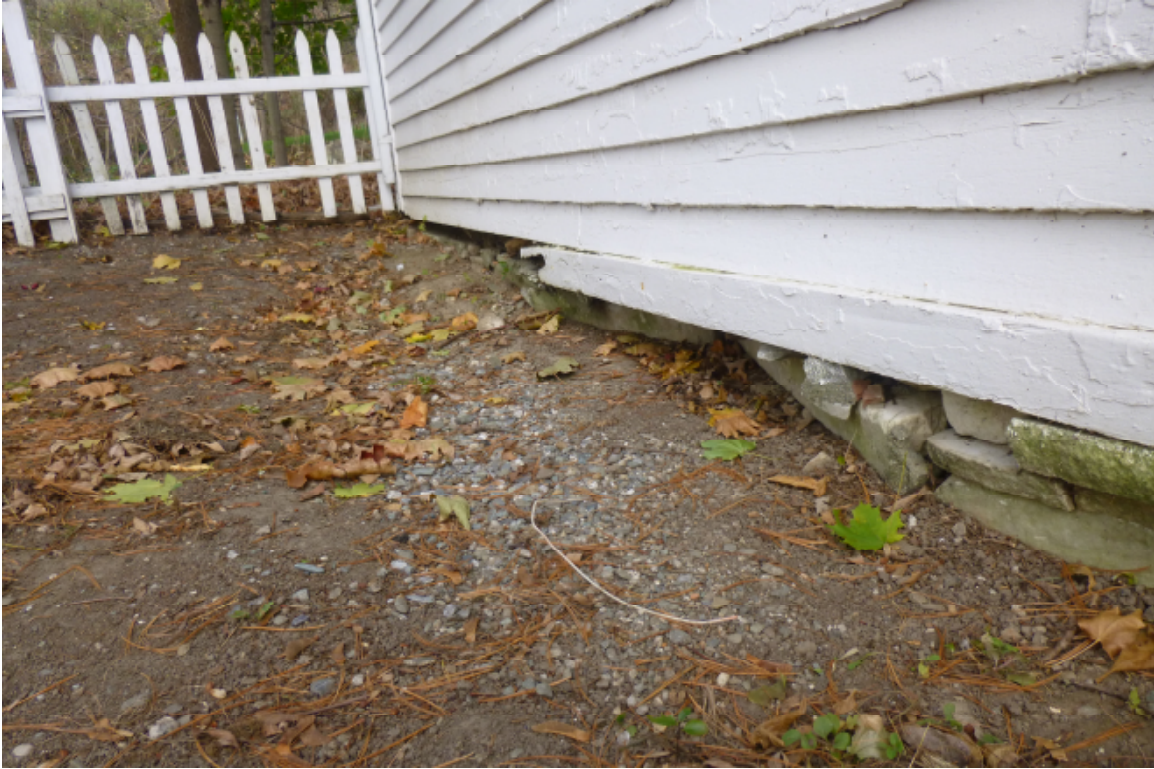
Image 10: Trim has rotted where near to, or against grade particularly the water table and the corner boards at the northwest corner where sections have disintegrated entirely. (South Egremont Village School, January 2014)

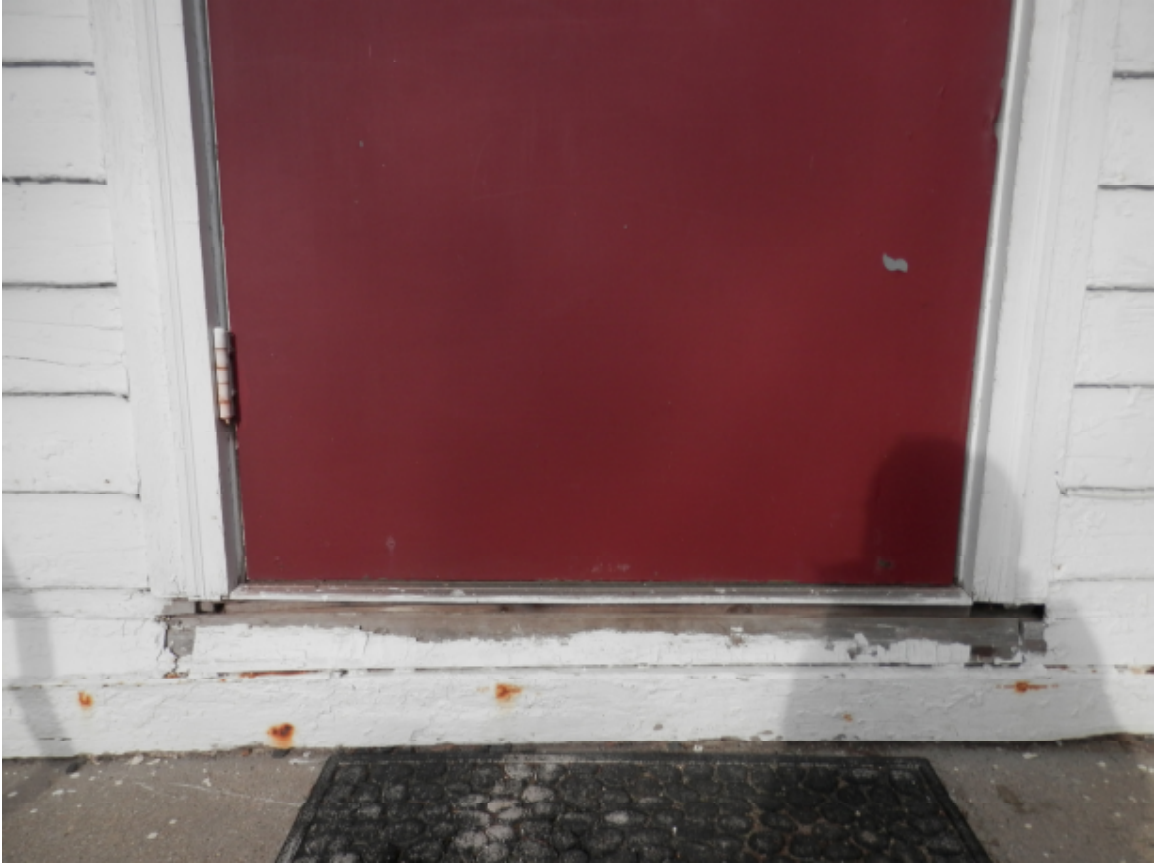
Image 11: Wood thresholds at the doors have been compromised and require repair.
(South Egremont Village School, January 2014)

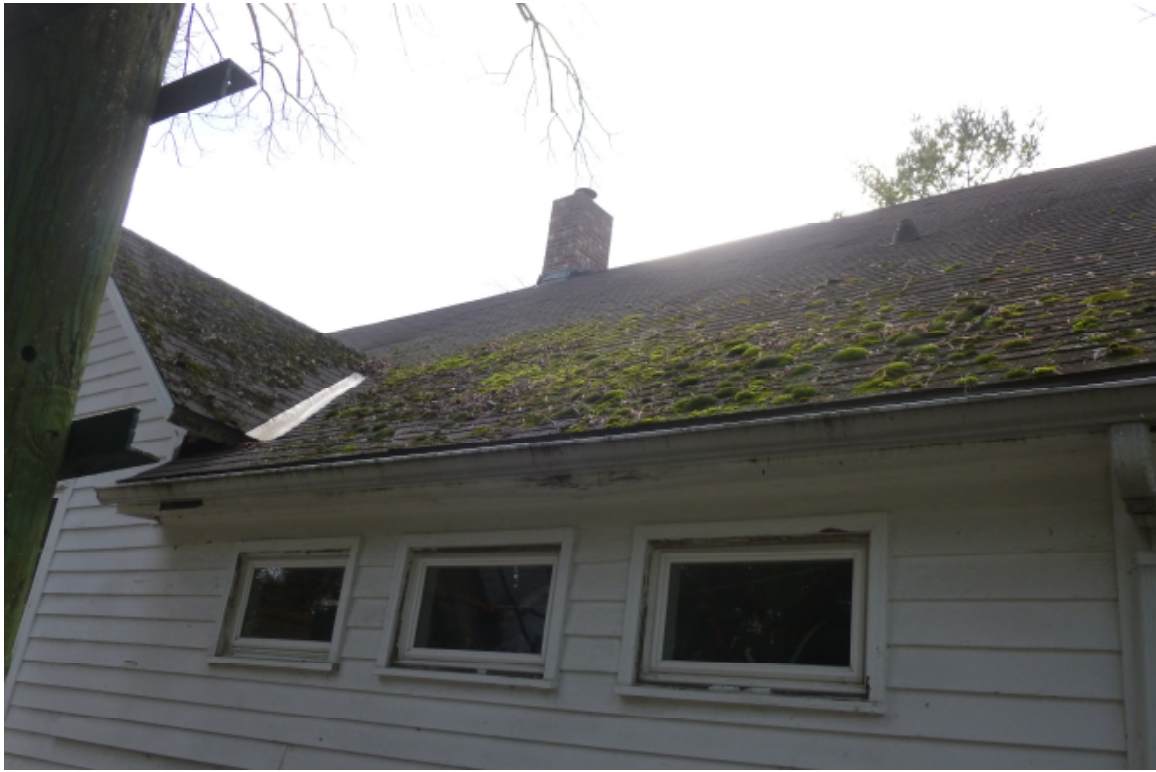
Asphalt shingles appear to be in good condition except for heavy biological growth on the east side of the main building and shed roof addition and the north side of the Entry Porch [Image 12]. The moss holds water against the shingles which accelerates their deterioration. The exposed section of the chimney appears to be well pointed and the flashing appears to be sound. There is surface-applied flashing where the cross gable roof of the Entry Porch intersects with the clapboards of the main building.

Image 12: Asphalt shingles appear to be in good condition except for heavy biological growth on the east side of the main building and lean-to and the north side of the entry porch. (South Egremont Village School, January 2014)

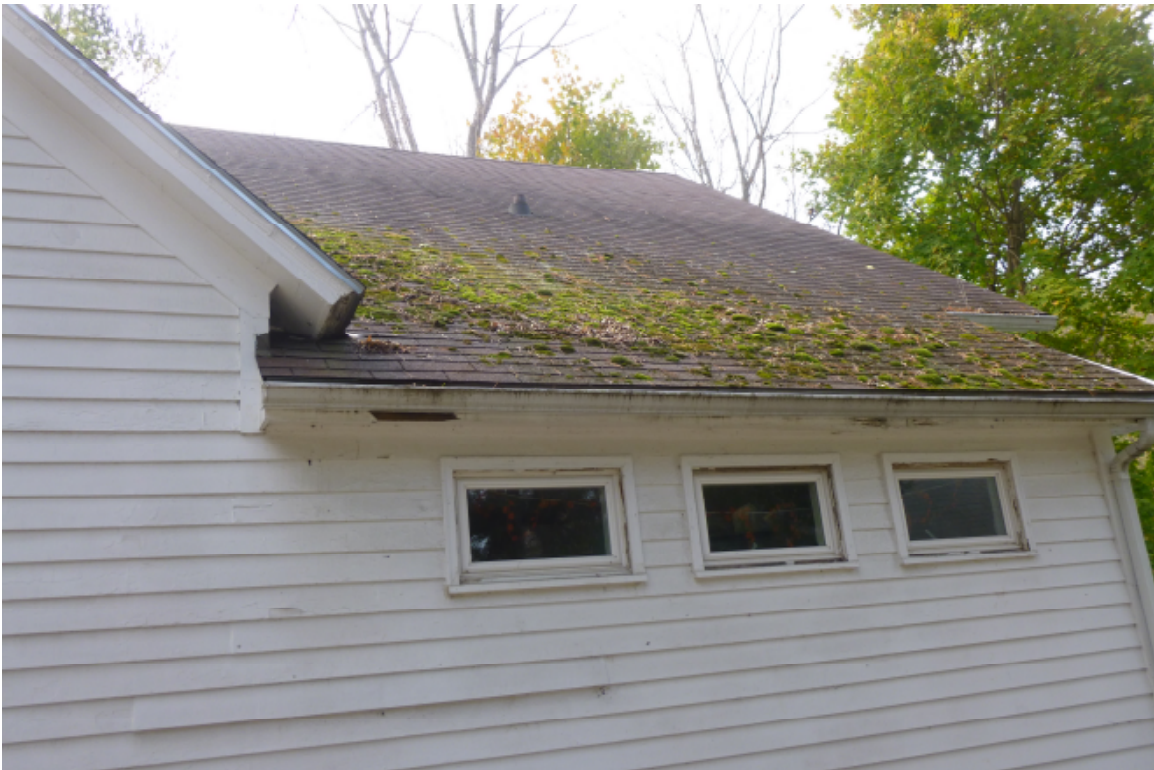
The roof has K-type aluminum gutters around the entire perimeter. As previously described, the roof has a large surface area; gutters seem to be undersized and appear inadequate to handle the roof run-off. Most damage to the wall surface, including paint loss and wood rot, has occurred below the gutter over the lean-to on the east side. In addition, the gutters are leaking at the joints and the leader outlets [Image 13].

Image 13: Most damage to the wall surface, including paint loss and wood rot, has occurred below the gutter over the lean-to on the east side. In addition, the gutters are leaking at the joints and the leader outlets. (South Egremont Village School, January 2014)

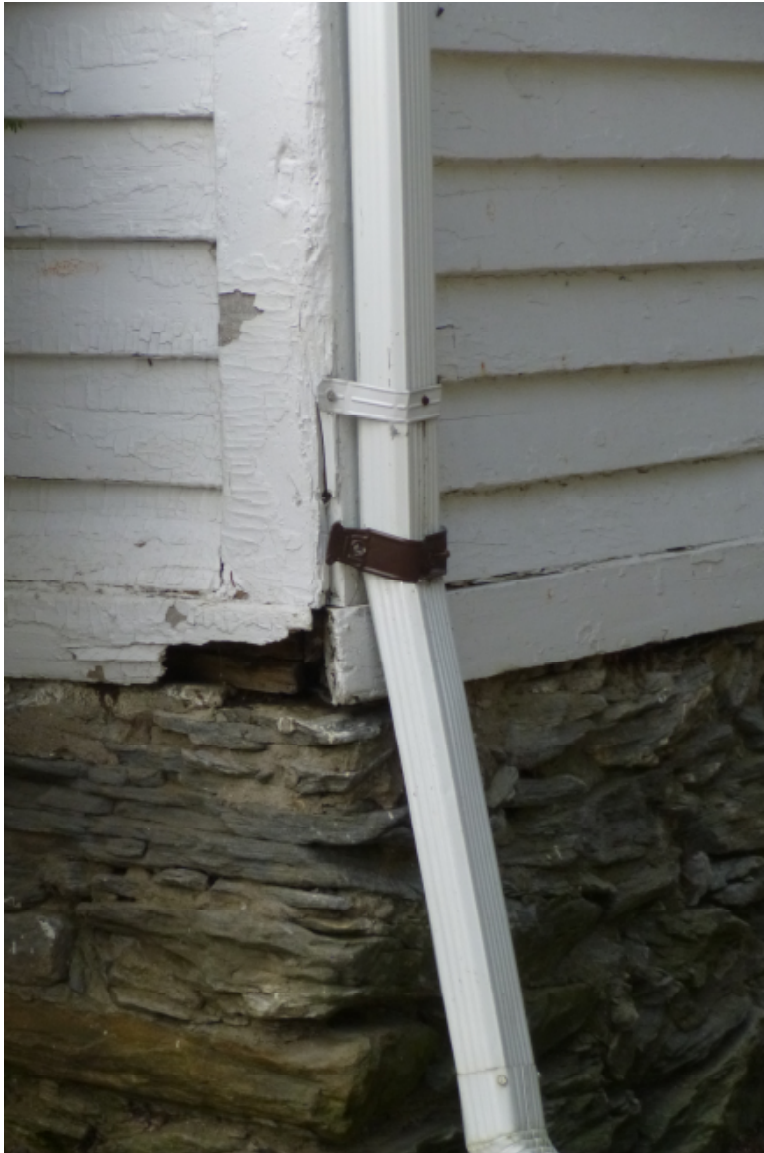
The most severe damage to the building foundation and superstructure appears to be occurring where the roof leaders discharge the rain water [Image 14]. The leaders have no splash blocks with which to disperse and direct away water from the building. At the northwest corner, the roof leader is discharging large quantities

Image 14: The most severe damage to the building foundation and superstructure appears to be occurring where the roof leaders discharge the rain water. (South Egremont Village School, January 2014)

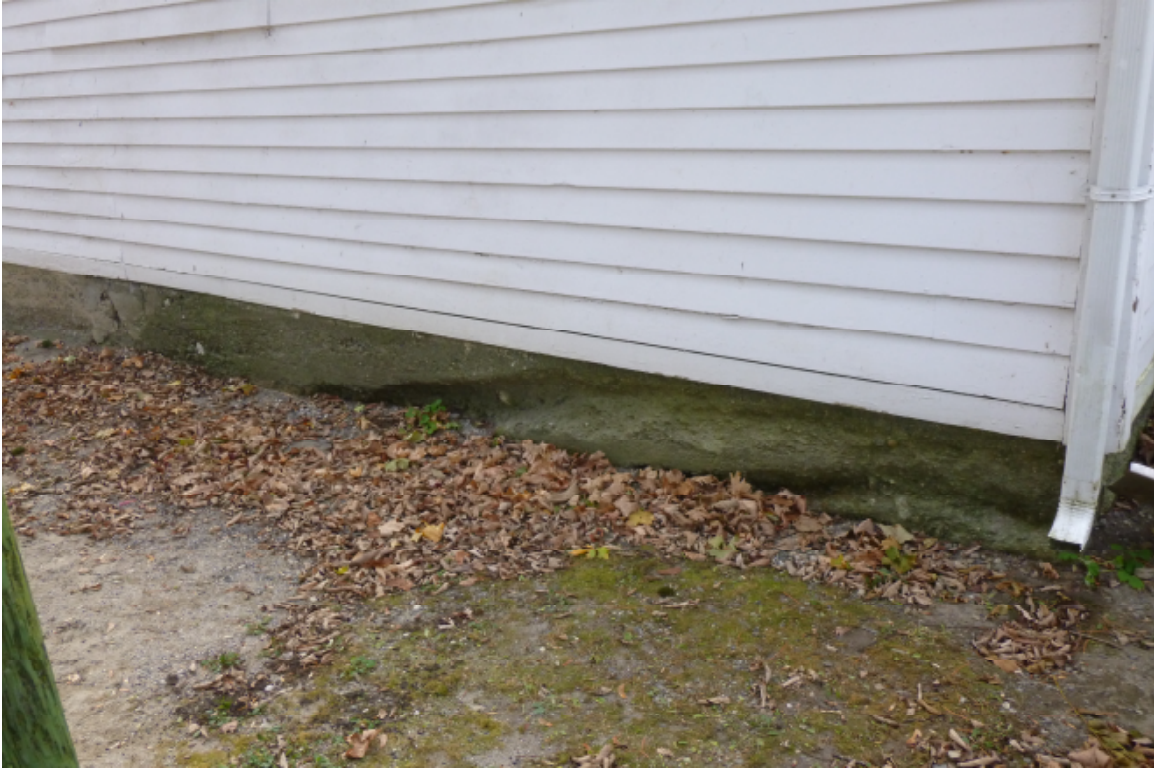
of water directly against the wood building elements above the foundation [Image 15].

Image 15: The leaders have no splash blocks with which to disperse and direct water from the building. At the northwest corner the roof leader is discharging large quantities of water directly against the wood building elements above the foundation. On the northeast corner, water discharge has led to wetting of the foundation and spalling of the foundation during the freeze / thaw cycle. (South Egremont Village School, January 2014)

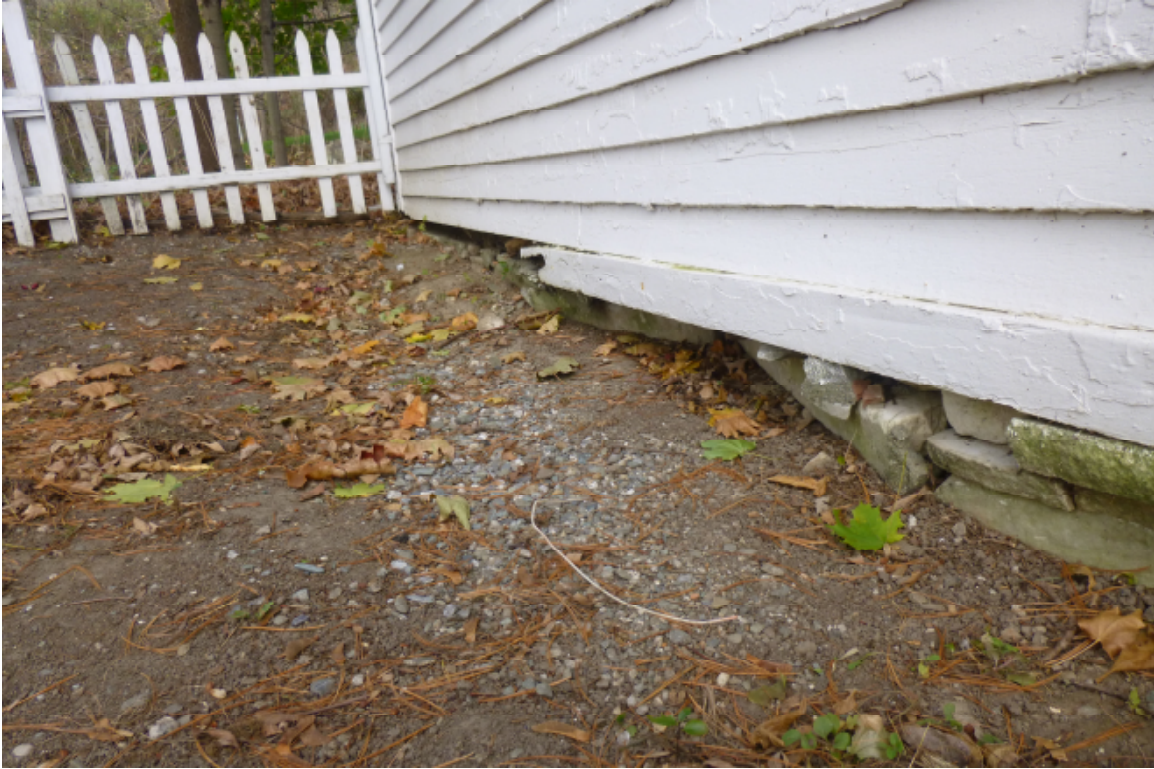
It appears that soil and organic debris from trees and grass is accumulating at the north side of the site and against the building to the point of raising the ground level near to or above the top of the stone foundation (it is also possible that the building was improperly planned initially). This is dramatically affecting site drainage and is probably contributing to the severe erosion of the concrete at the northeast corner and the collapse of the foundation at the northwest corner [Image 16].

Image 16: Soil and organic debris from trees and grass is accumulating at the north side of the site and against the building to the point of raising the ground level near to or above the top of the stone foundation (it is also possible that the building was improperly sited initially). This is dramatically affecting the site drainage and is probably contributing to the severe erosion of the concrete at the northeast corner and the collapse of the foundation at the northwest corner.
(South Egremont Village School, January 2014)

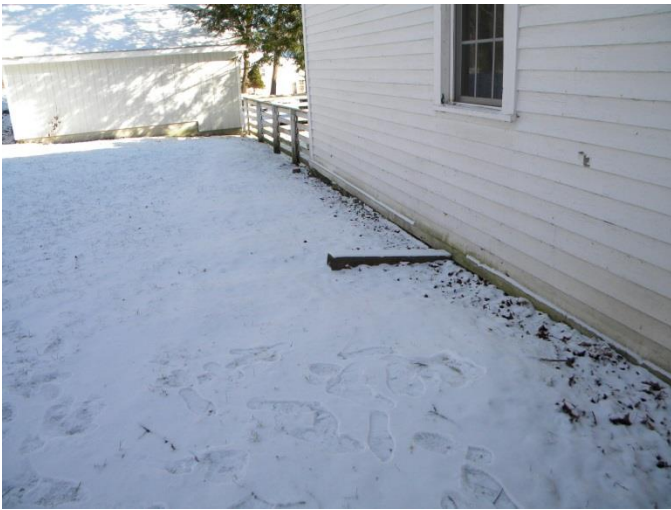
Rear (north) Elevation – note proximity of grade to siding

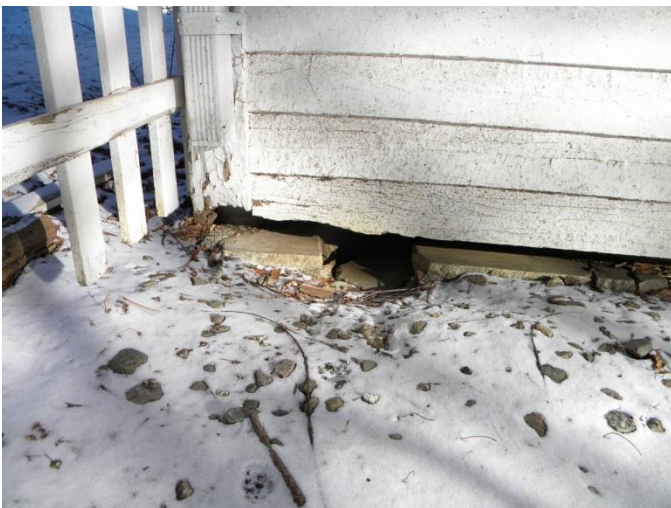
Northwest corner – note deteriorated siding

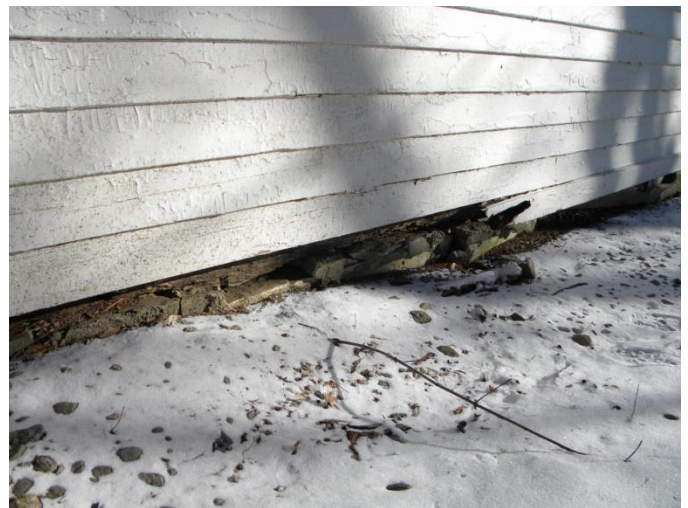
Northwest corner – note deteriorated siding

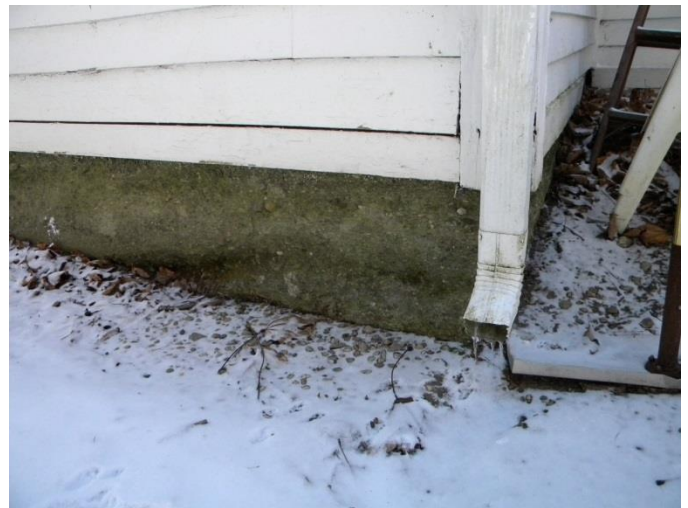
Note deteriorated concrete

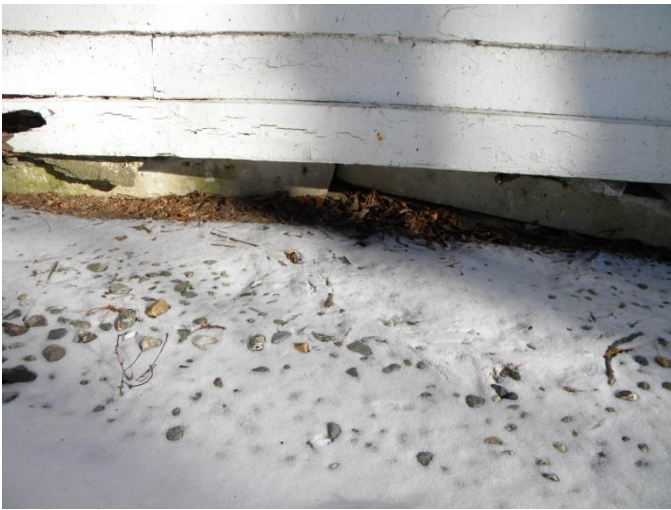
Displaced foundation stone

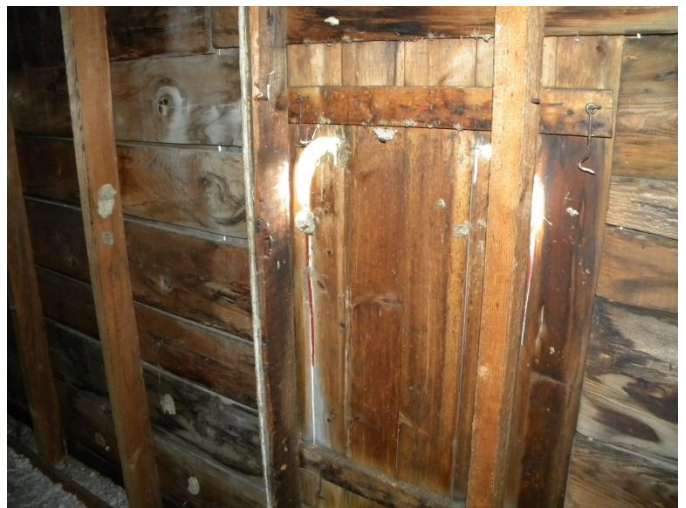
'Door' at front gable, note wasp nest near opening

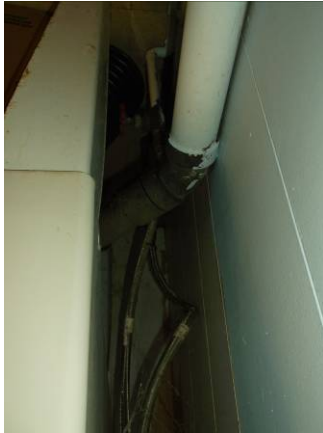
Located within the slab the cast iron sanitary system is routed to the bathroom plumbing fixtures. Vertical piping from the plumbing fixtures appeared to be pvc and cast iron piping. The piping appeared to be in fair condition with signs of leakage. Replacement is warranted due to condition.

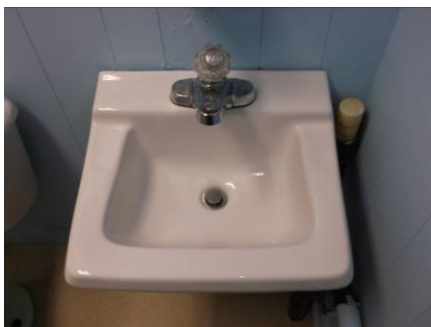
Wall mounted lavatories were found in the boys/girls bathrooms. Piping beneath the fixture appeared to be copper with braided steel connections for domestic and steel to pvc for sanitary. Corrosion is present on the braided connections and piping. The lavatories appeared to be over twenty five (25) years old and in fair condition. Replacement is warranted due to age, condition and water consumption.

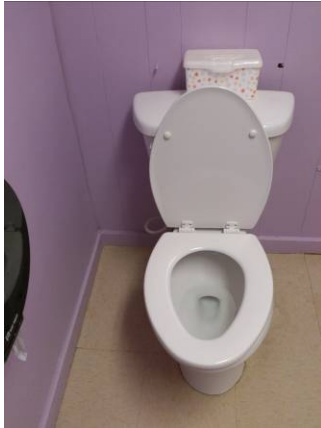
The bathrooms are equipped with a tank type water closets located adjacent to the lavatory. The water closets are manufactured by the Kohler/Mansfield Companies and appears to be in fair condition. Corrosion is present at the braided connection and shut off valve. Replacement is warranted due to age, condition and water consumption.

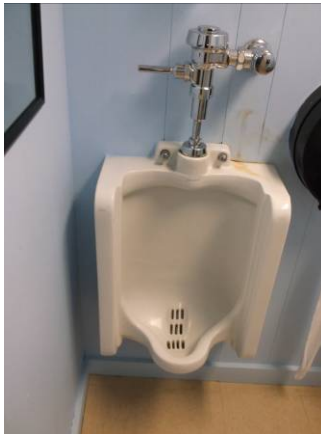
A wall hung urinal was observed in the boys bathroom. The urinal is manufactured by the American Standard Company and appears to be over twenty five (25) years old. The shut off valve assembly appeared to be recently installed and in good condition. Replacement of urinal is warranted due to age.

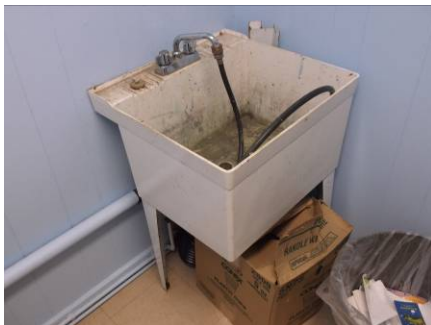
A service sink is located within the boys room. The domestic piping is non-insulated copper with braided connections and shut off valves. The sink and valves appeared to be in poor condition with corrosion present. Replacement is warranted due to condition.

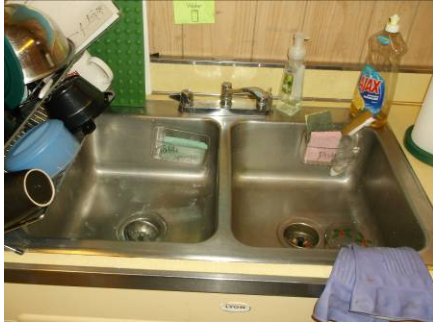
A double bowl stainless steel sink is located within one of the classrooms. The domestic piping is non-insulated copper with braided connections and shut off valves. The sink and valves appeared to be over twenty five (25) years and in fair condition. Replacement is warranted due age and water consumption.

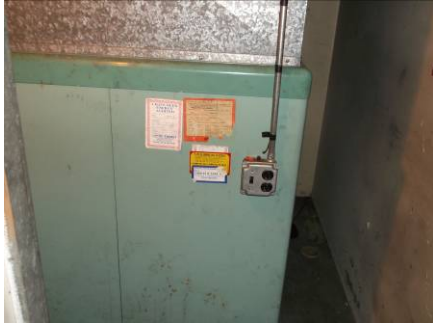
Space heating is provided by an oil fired furnace located in the mechanical room. The furnace is an Williamson Oil Saver with matching fuel oil burner. During startup the furnace "puffed back" within the mechanical room. The furnace and burner unit to be over twenty five (25) years old and in poor condition. Replacement is warranted due to condition, age and efficiency.

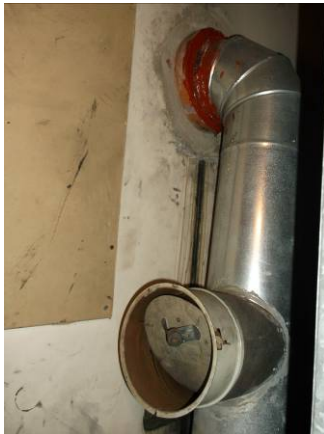
Breeching for the furnace is routed to a chimney stack. The breeching has a barometric damper and minor corrosion at the connection point. Replacement is warranted due to furnace change out.

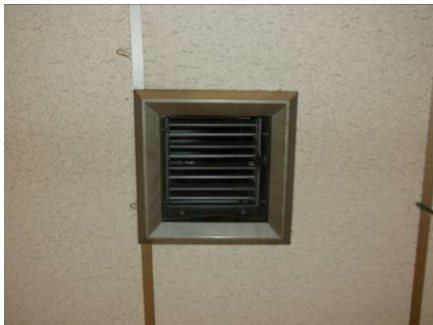
Air distribution within the space is provided through ceiling/wall mounted supply grilles. The grilles appeared constructed of aluminum, over twenty five (25) years old and appeared to be in fair condition. Replacement is warranted due to age.

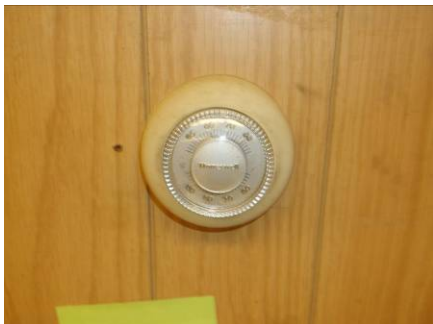
Two (2) wall mounted non-programmable thermostats manufactured by the Honeywell Company were observed. The thermostats are mounted near the duct mounted return grilles. Each grille appeared to be over twenty five (25) years old and in fair condition. Replacement is warranted due to age.

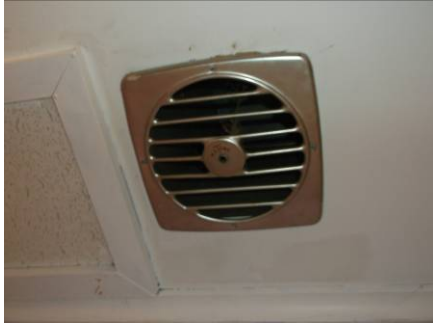
Exhaust for the bathrooms are provided by ceiling mounted exhaust fans manufactured by the Nutone Company. The fans are currently non-operational and over twenty five (25) years old. Replacement is warranted due to condition and age.

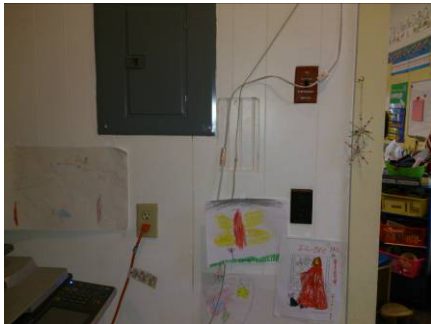
The receptacles within the building are type NEMA 5 duplex receptacles. The quantity is limited and the locations do not appear to be user friendly and therefore are causing the use of receptacle power blocks and extension cords to be utilized in a couple of areas. The few receptacles the building does contain are primarily recessed mounted with a few receptacles being installed in surface mounted raceway (wiremold). No receptacles were observed within the restrooms. The lone kitchen counter top receptacle was a

The existing receptacles should be removed and replaced due to their age. Additional GFCI receptacles should be installed in the kitchen counter top, domestic water heater closet and mechanical room as well as an exterior weatherproof receptacle located near the proposed mechanical condensing unit to comply with current code. Tamper resistant GFCI receptacles should be installed in the restrooms to comply with current code.

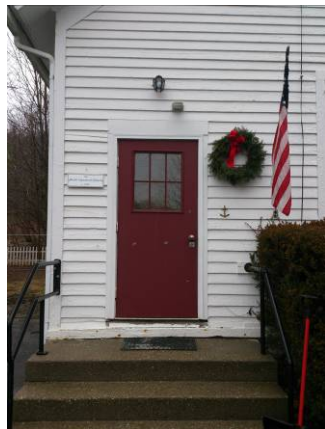
The combination emergency lighting / exit signs appear to be in good condition. However, the dual head lens require adjustment as one of the lens are pointing upward on a couple of the fixtures.
